Property Inspection Report

Integrity Inspections

2114 W. WILLOW AVE.
ANAHEIM, CA. 92804

02/08/07

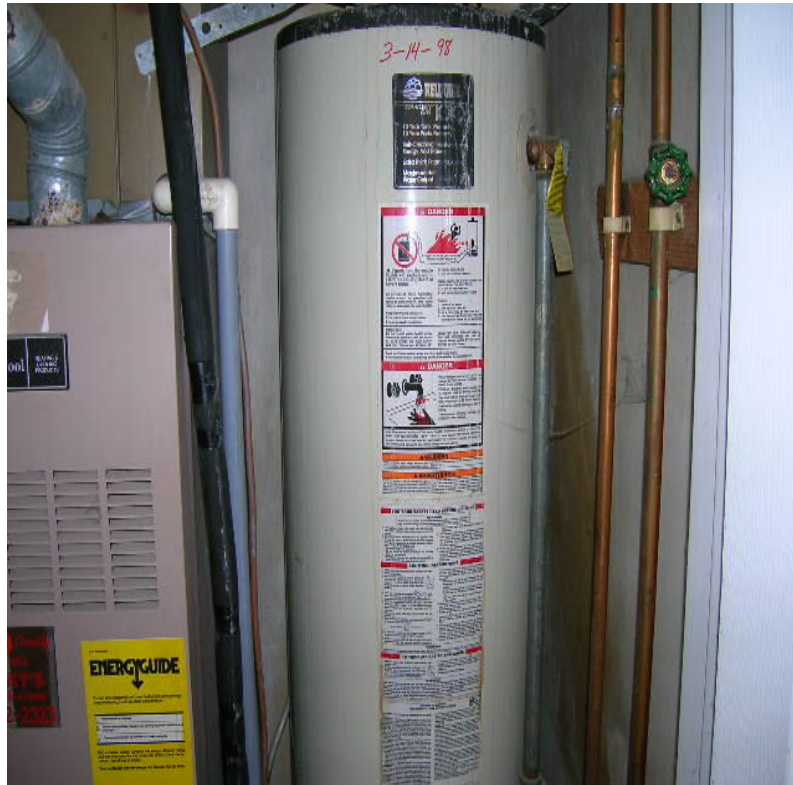
See picture 4A

Location A: Laundry room B: _____ C: _____
 Type: GAS Gallons: 40
 Appears serviceable*
 Near end of lifespan/worn*
 Pilot/system off--could not inspect
 Corrosion on pipes
 Burner flame appears improper
 Heater leaks
 Water shutoff valve installed(no test)
 Valve missing/broken/leaks
 T.P.R. valve installed on tank
 No T.P.R. valve
 T.P.R. pipe appears serviceable
 T.P.R. pipe missing
 Combustible air is available
 Air supply blocked/none provided
 No gas line dirt leg
 Insufficient clearance to combustible material
 Vent flue piping is serviceable
 Pipe damaged/missing/disconnected
 Water heater platform damaged
 Gas flame in garage is not 18" above floor
 Seismic straps serviceable
 Not Strapped properly

WATER HEATER NOT PROPERLY STRAPPED

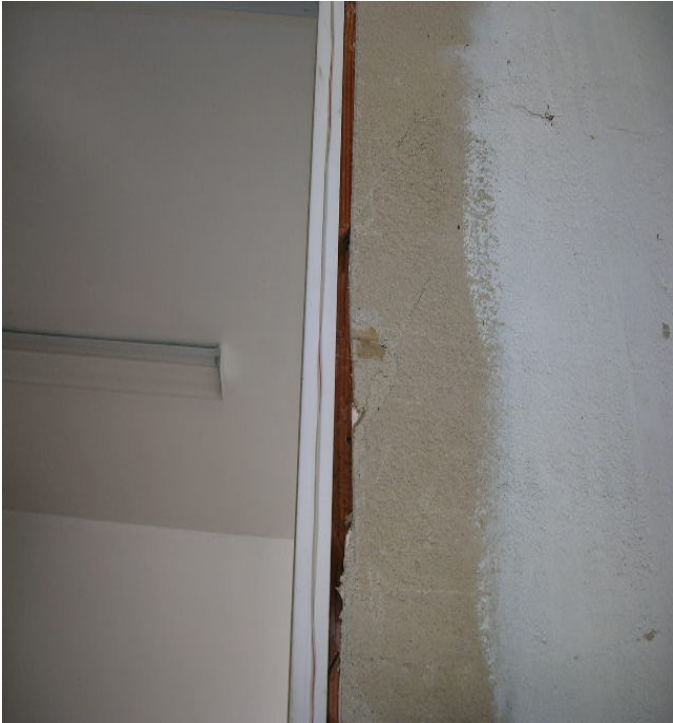
AREA AROUND DOOR NEEDS TO BE SEALED PROPERLY
THIS IS A FIREWALL

Comments: Holes in wall against living area needs to be properly sealed this is a firewall

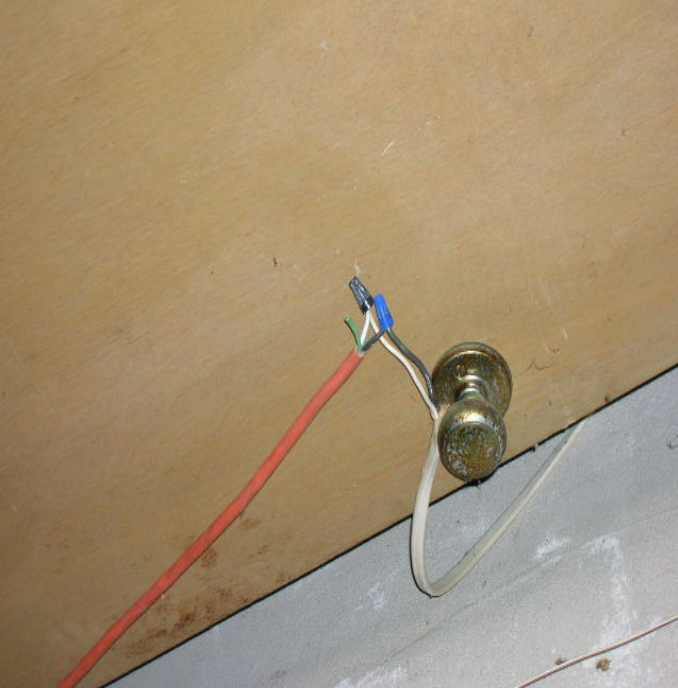
Electrical **Appears serviceable** Damage/deterioration Improper wiring
 Junction boxes missing covers Open ground/ rev polarity
 Outlets serviceable GFCI Recommended **Ext. cords used as permanent wiring**
 Outlets not functional Loose damaged outlets Exposed wiring subject to damage

IMPROPER WIRING FOR OUTSIDE LIGHT. EXTENSION
CORD TIED INTO WIRING

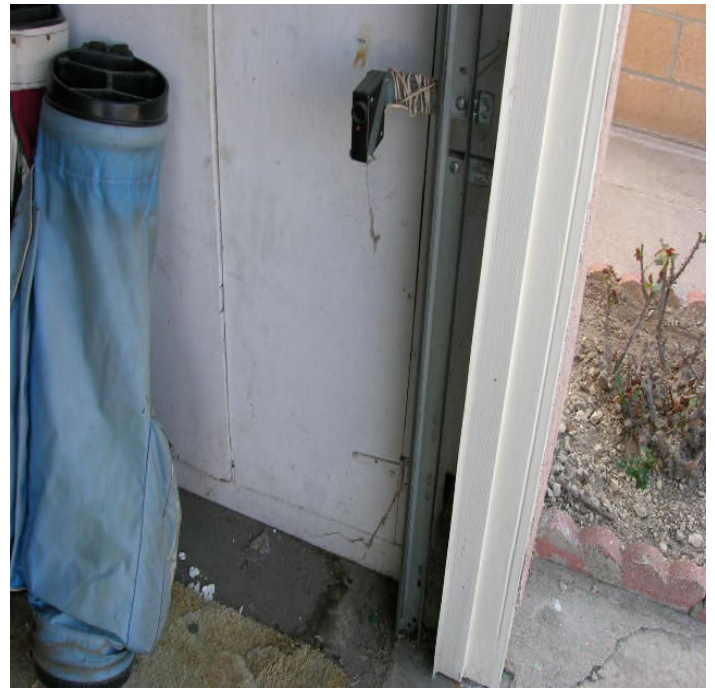
Automatic Opener # of units 1
 Appears serviceable Unit is not working **None**
 Automatic reverse operated **Auto reverse sensors to high**

SENSORS FOR GARAGE DOOR OPENER NEED
TO BE 3-4 INCHES OFF GROUND

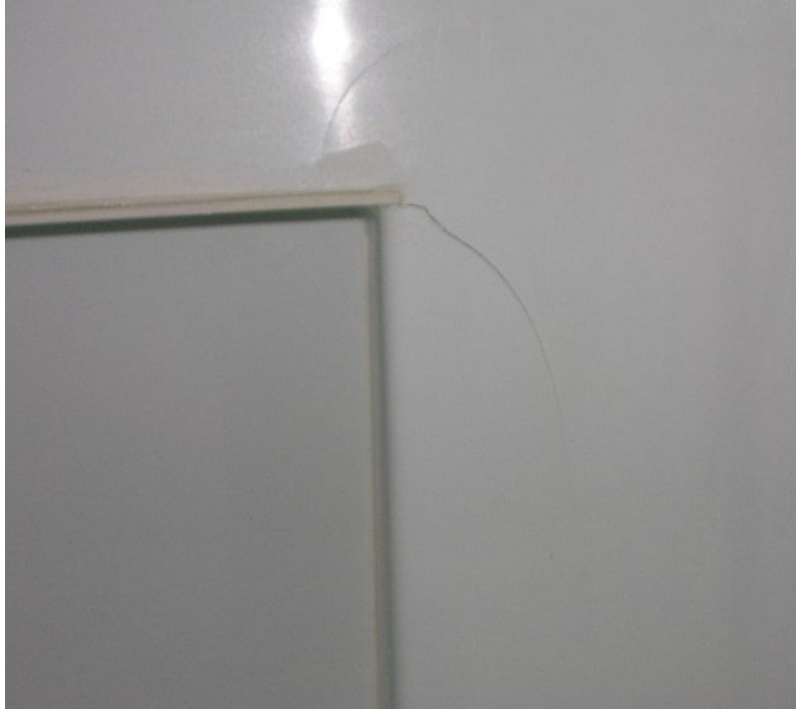
Appears serviceable	X	X	
Damage to shower wall	X		
No shower diverter			
Faucet appears ok	X	X	
Constant dripping			
Drain appears ok	X	X	
Enclosure appears ok	X

CRACK IN SHOWER WALL IN 1ST HALL BATHROOM

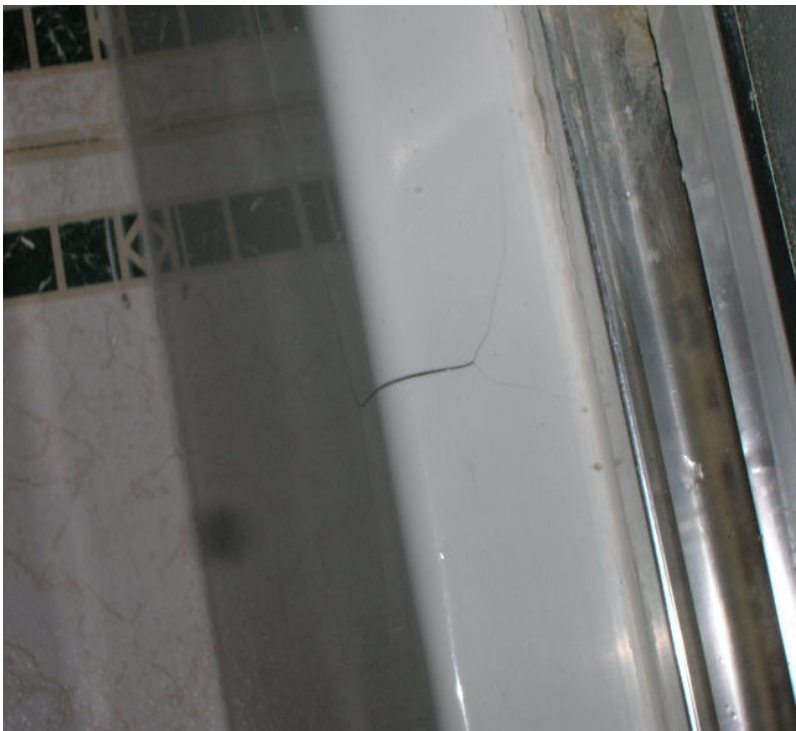
CRACK IN STEP FOR SHOWER IN 1ST HALL BATHROOM
